KODACHROME SLIDES \* REGION 5

Furnished by Harold J. Swan, Head, Regional Current Information Section

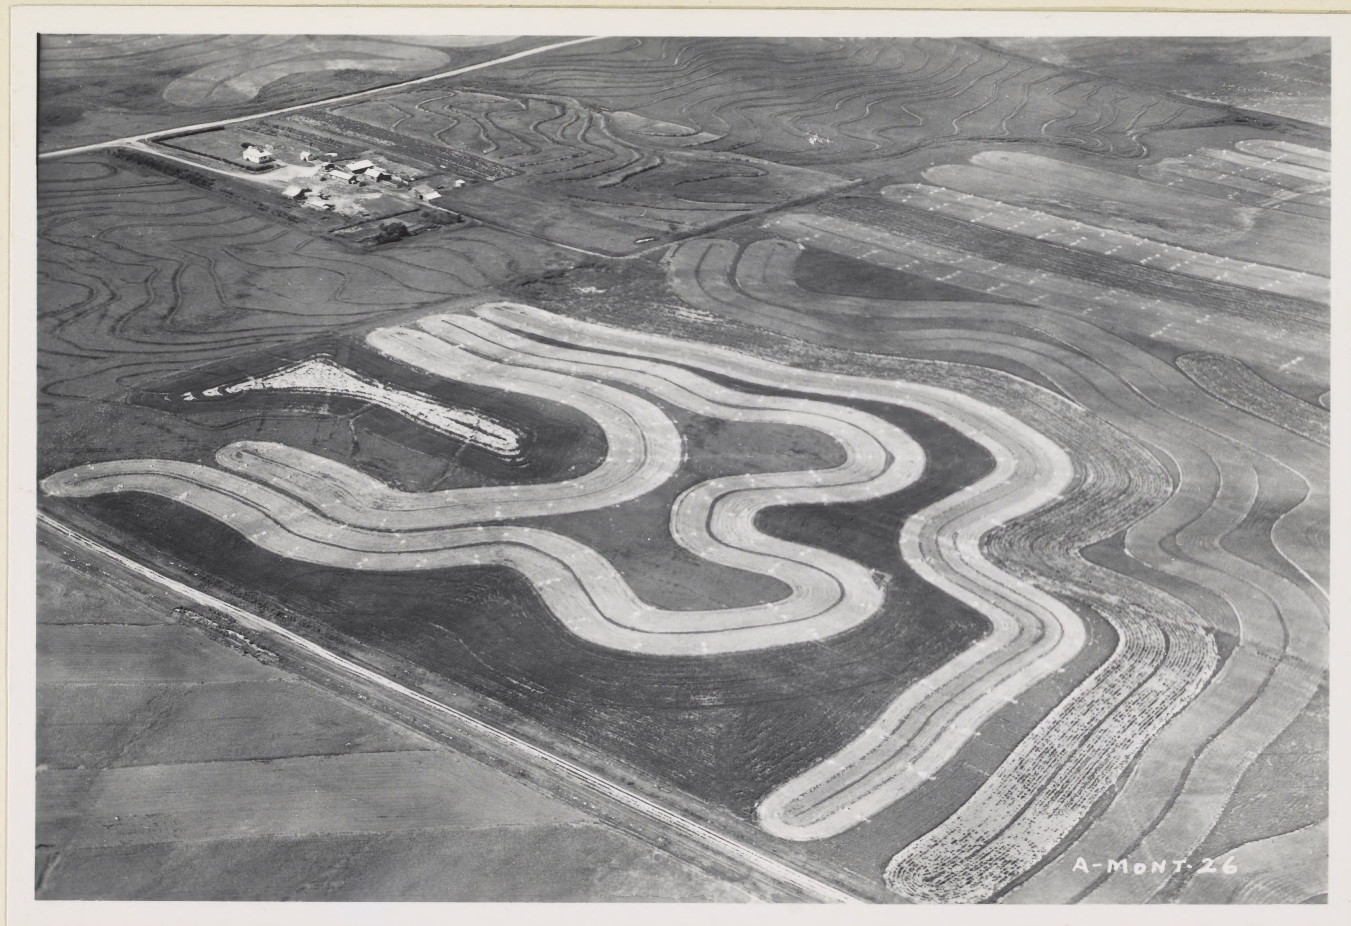
A-Mont-26

Contour strips in the immediate foreground were 6 rods wide, the irregular area between the strips being taken up by grass buffers. On both sides of the farm may be noted a system of pasture terraces. Wind erosion had been severe, as the soil was light and fine, and it was planned to retire the land to permanent grass for pasture. Mr. Fryhling owned and operated an additional 80 acres not shown in this picture, but which were also laid out in contour strips.

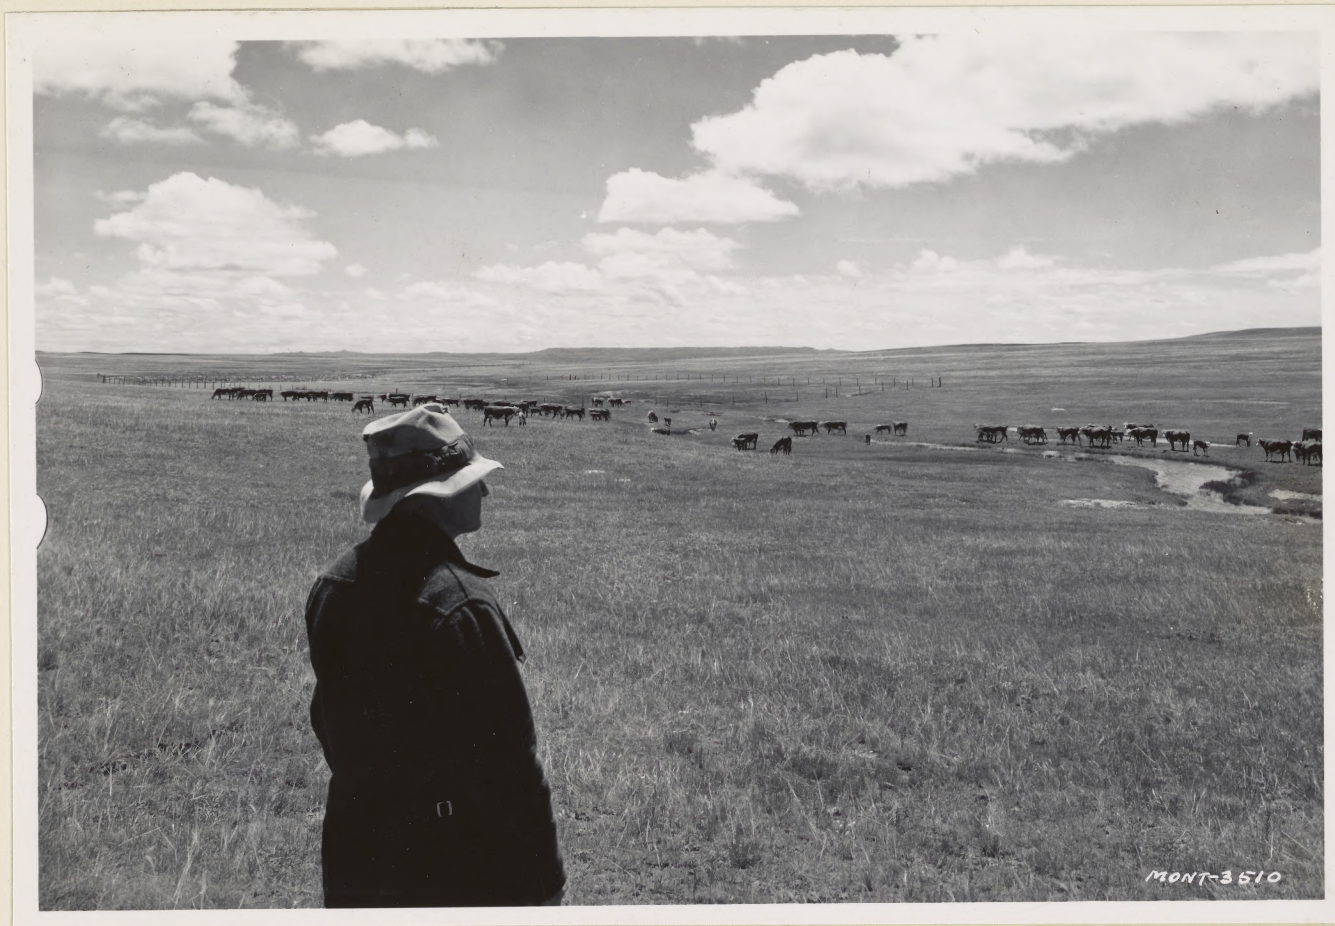
Mont-3510 Musselshell County 6-14-39  
 A convenient watering place in this pasture made it unnecessary for this herd of registered Hereford cattle to go far for water. The owner of the cattle, J. A. Kenninger, is shown here looking at them as they pastured on land near a fenced-in wildlife area established around the dam he built for stock watering purposes. 12 miles northwest of Roundup, Montana.

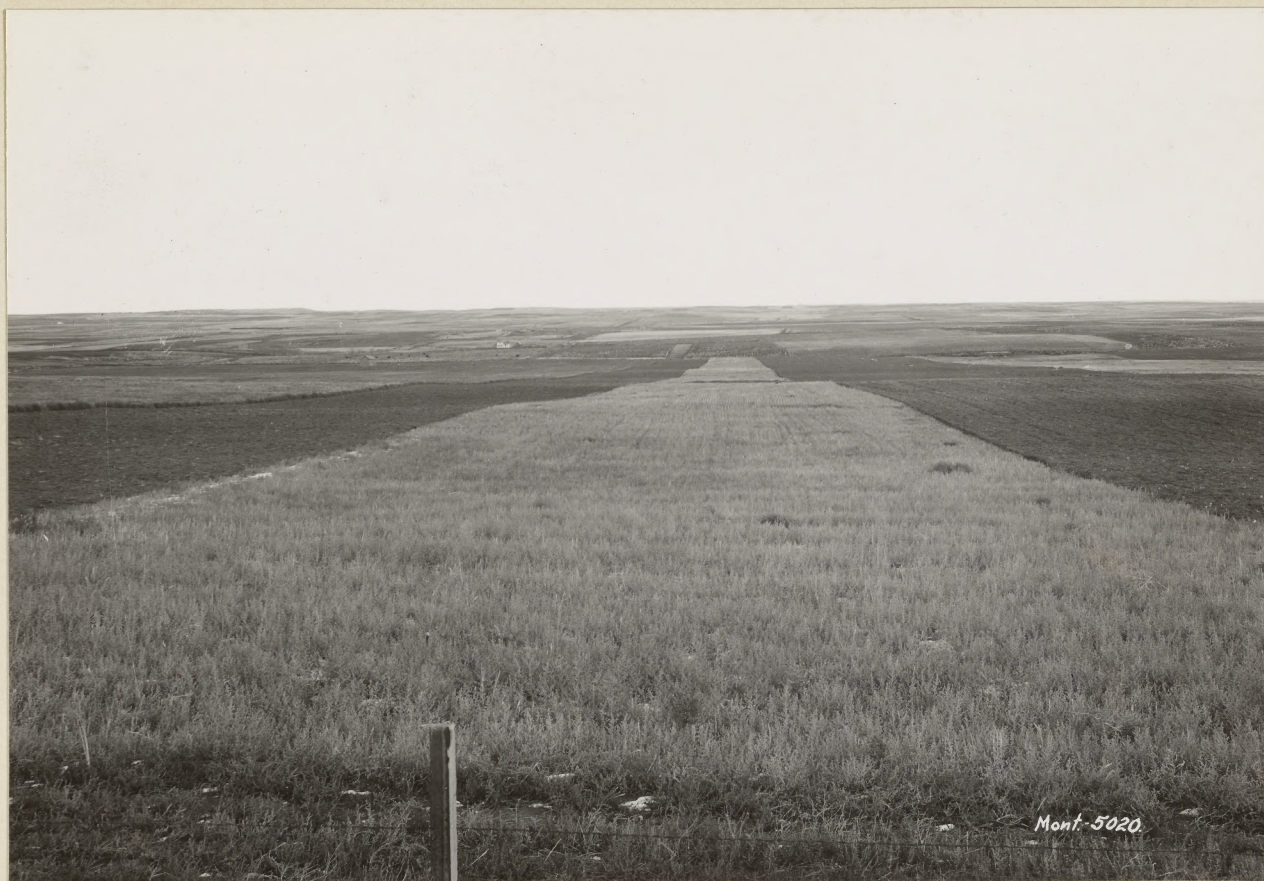
MONT-5020. Roosevelt County, Montana; 12-18-36.

Shows strip cropping east and west and up and down the slope. This practice is bad from both the wind and water erosion standpoint.

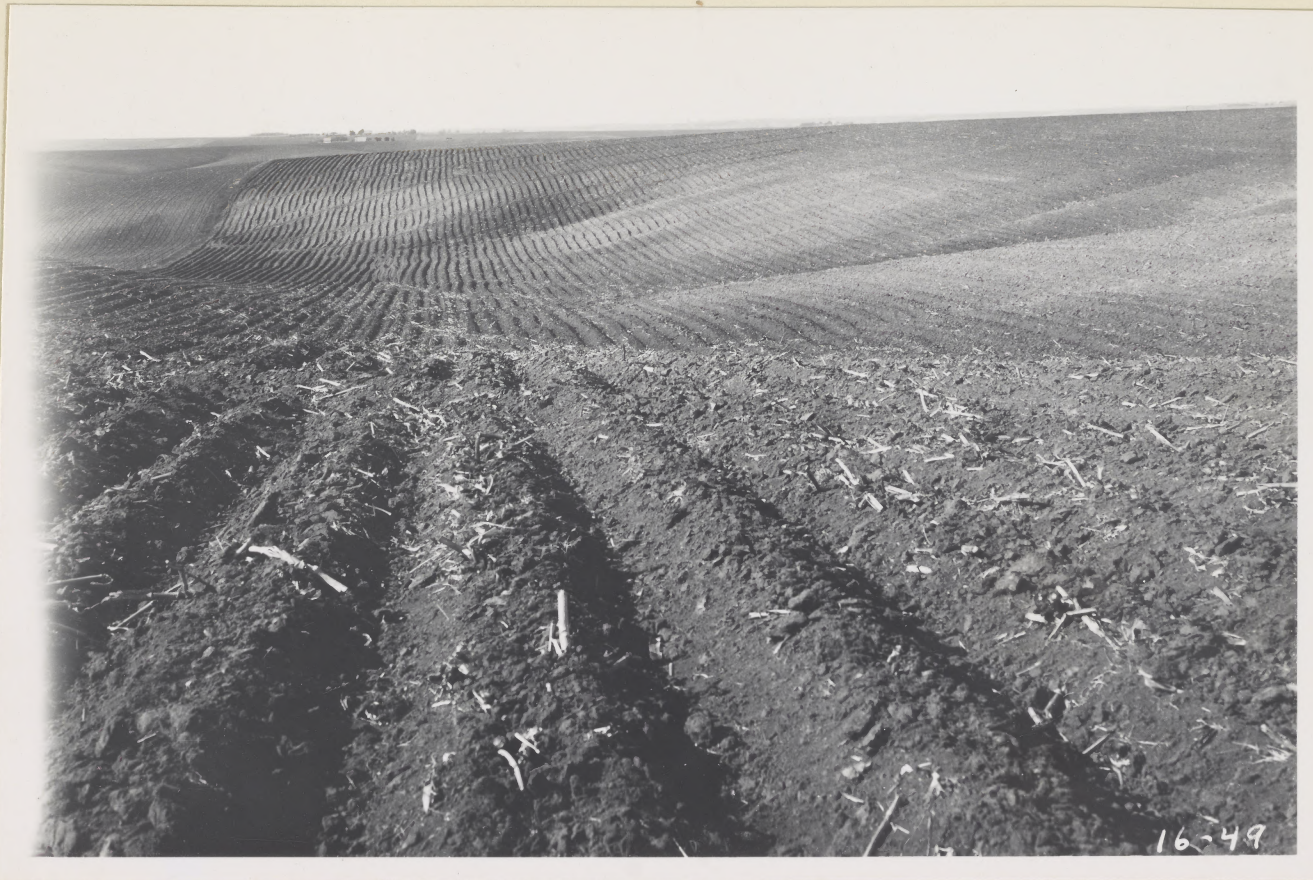
16-49

In the background can be seen extensive sheet erosion which is shown by the light spots in the background of the picture and the formation of fingerlike gullies. Also, in the distant background can be seen what appear to be furrows running at nearly right angles to the lister ridges. Placing these furrows in a lister planted cornfield is a common practice of farmers to try to prevent water running down the lister furrow on steeper slopes. Their intention is to divert the water diagonally down across the slope and, incidentally, it is one method that encourages gully formation. Located on the Vern Michael farm.

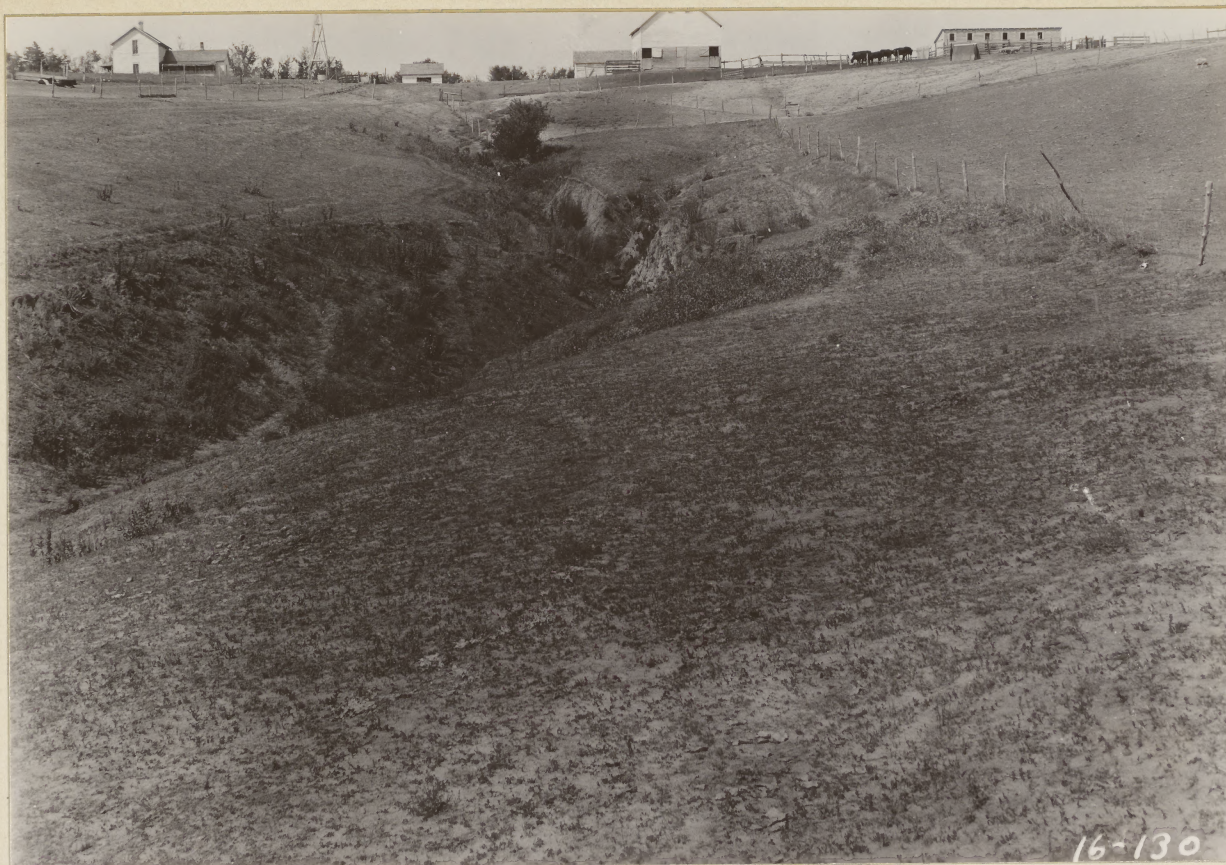
16-130. Nebraska.  
EROSION - Gully.

A deep and active gully advancing up the slope into the barnyard. This gully will be sloped, planted to trees, and an interception ditch constructed at the head. Same gully shown in 16-122. Nance County, Nebraska.

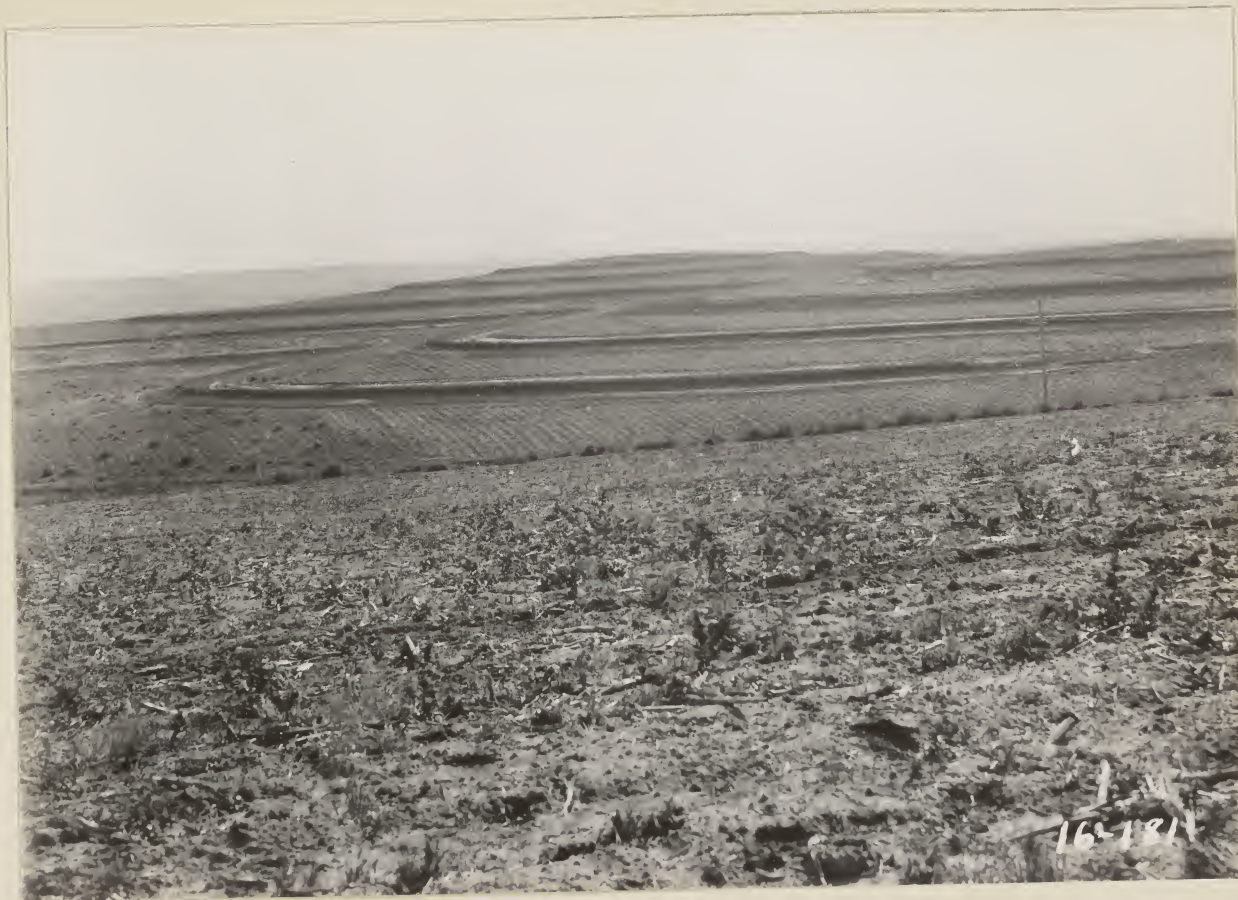
16-181 - Albion, Nebraska.  
EROSION CONTROL - Contour Listing.

Good view of series of contour terraces just completed. This farm  
will be contour listed this fall to conserve all moisture possible.  
SW $\frac{1}{2}$  Sec 29 twp 19 R 6.

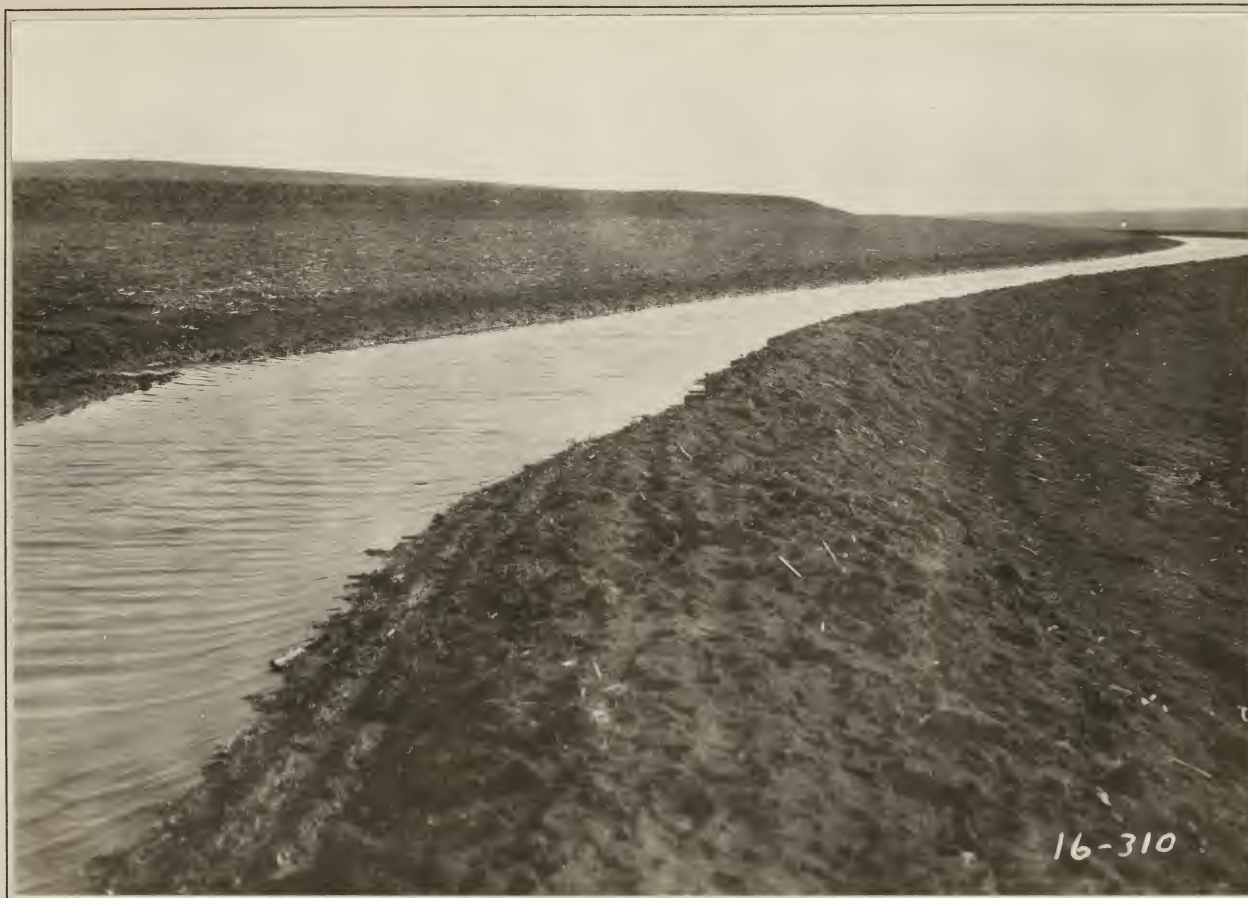
16-310 - Nebraska  
EROSION CONTROL - Terraces

Level terrace holding an enormous amount of runoff water. The width of this channel will average 12 feet for a distance of approximately one half mile. Approximately 2,370 barrels of water have been held behind this terrace. This collection of water is the result of a rapidly melting snow.

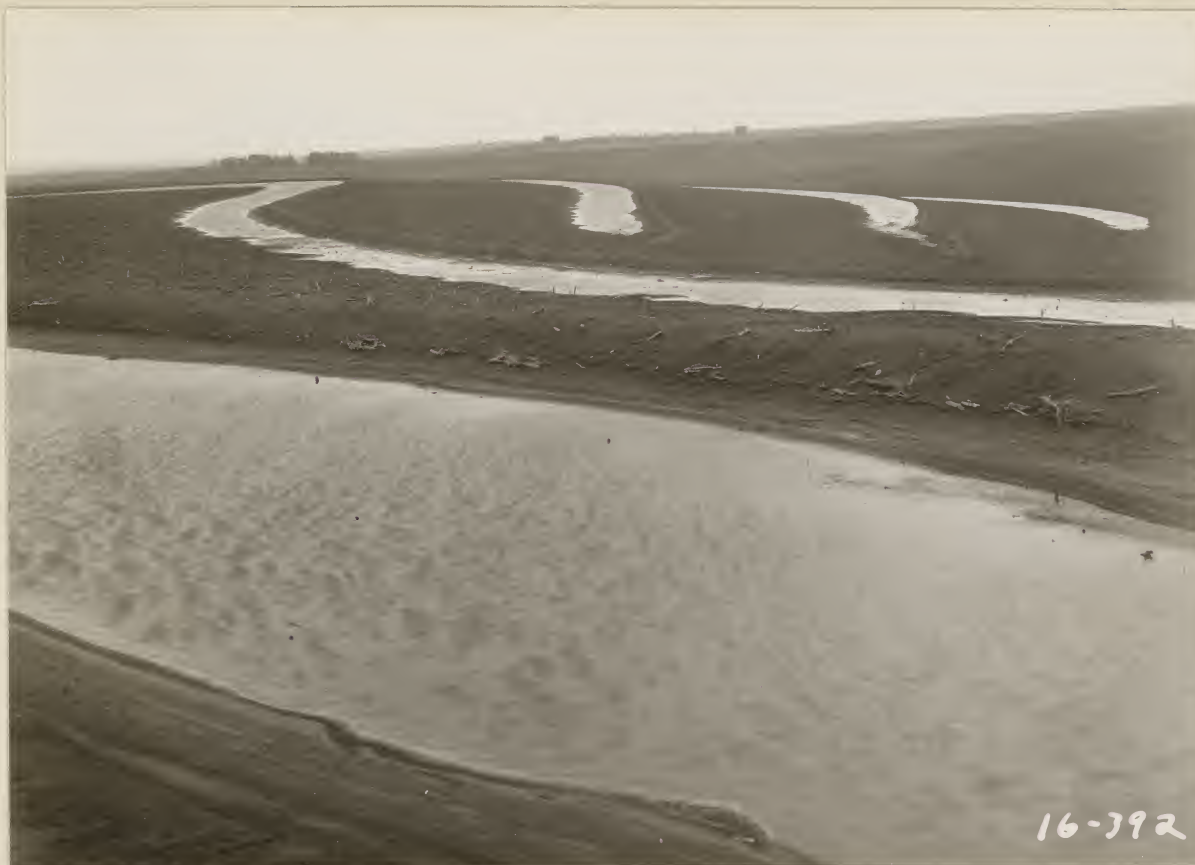
16-392. Boone county. A series of level terraces on a slope nearly full of water following a 3" rain. Active sheet erosion has been prevented as well as holding the runoff water on the land.

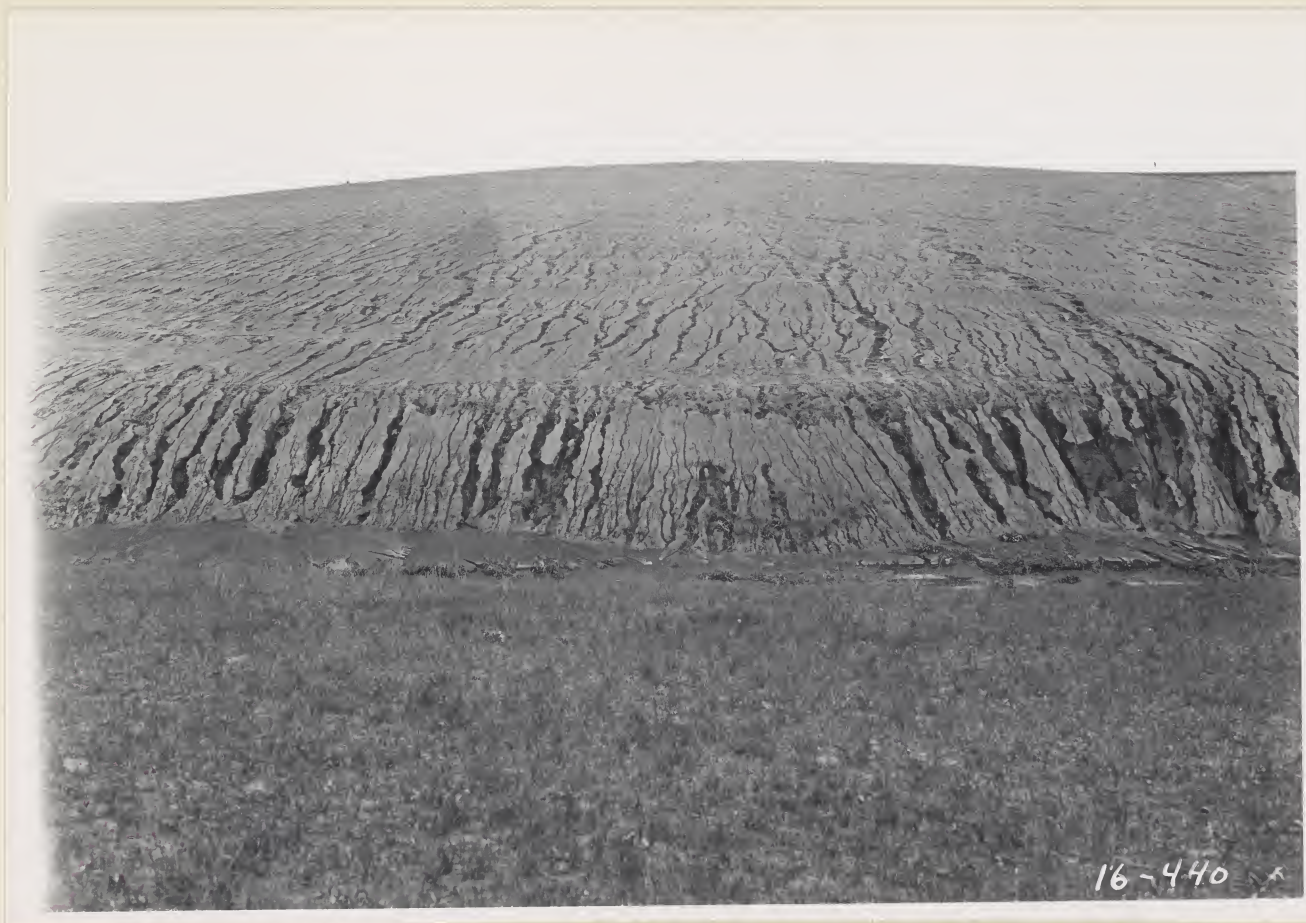
16-440

A cultivated field with a slope too steep to terrace. It should be in pasture. The field was in corn last year, and with no protective covering through the winter, and was subject to severe wind erosion during the early spring. The silt deposit in the foreground is the result of wind and spring rains did the rest.

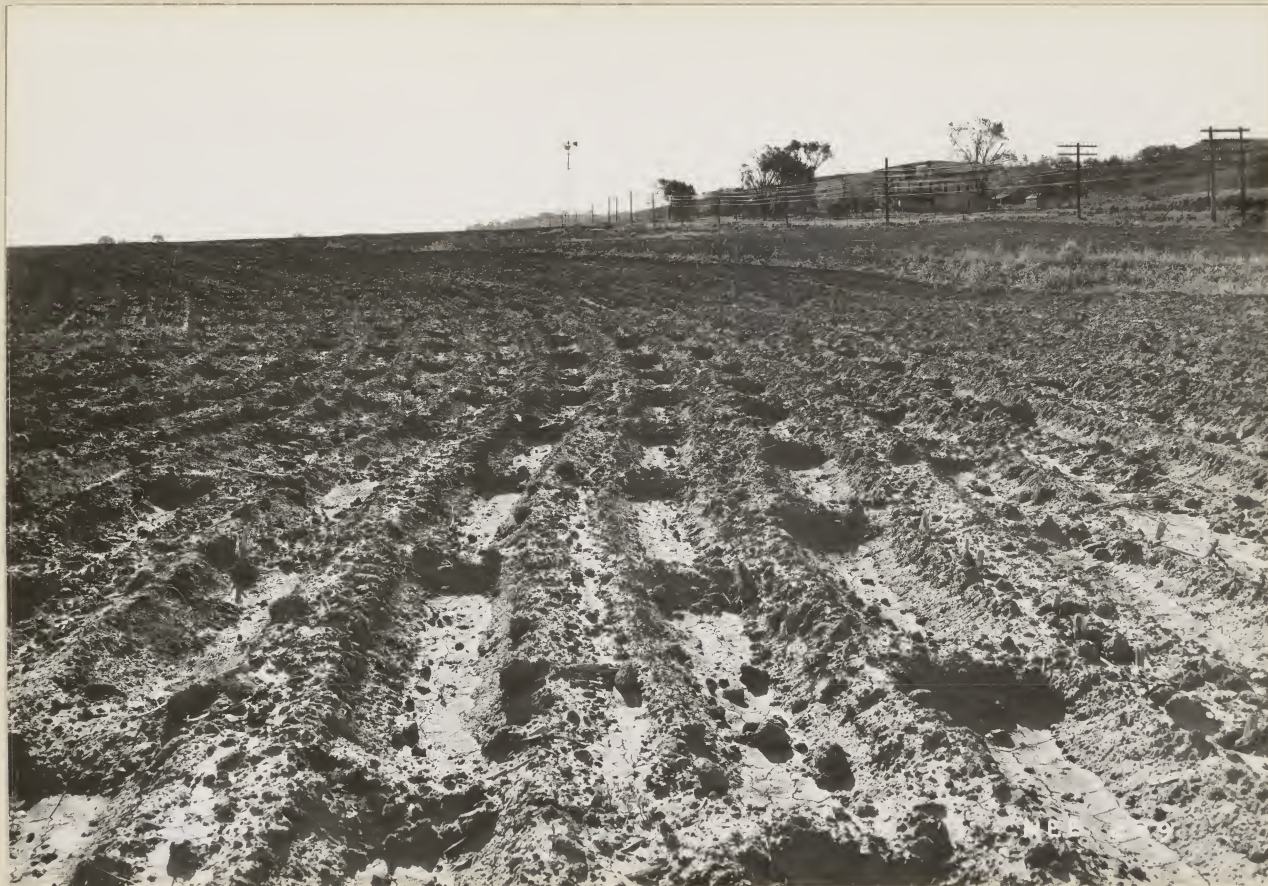
Neb-229. Nebraska.  
EROSION CONTROL - Listing.

Blank basin listing on the contour.

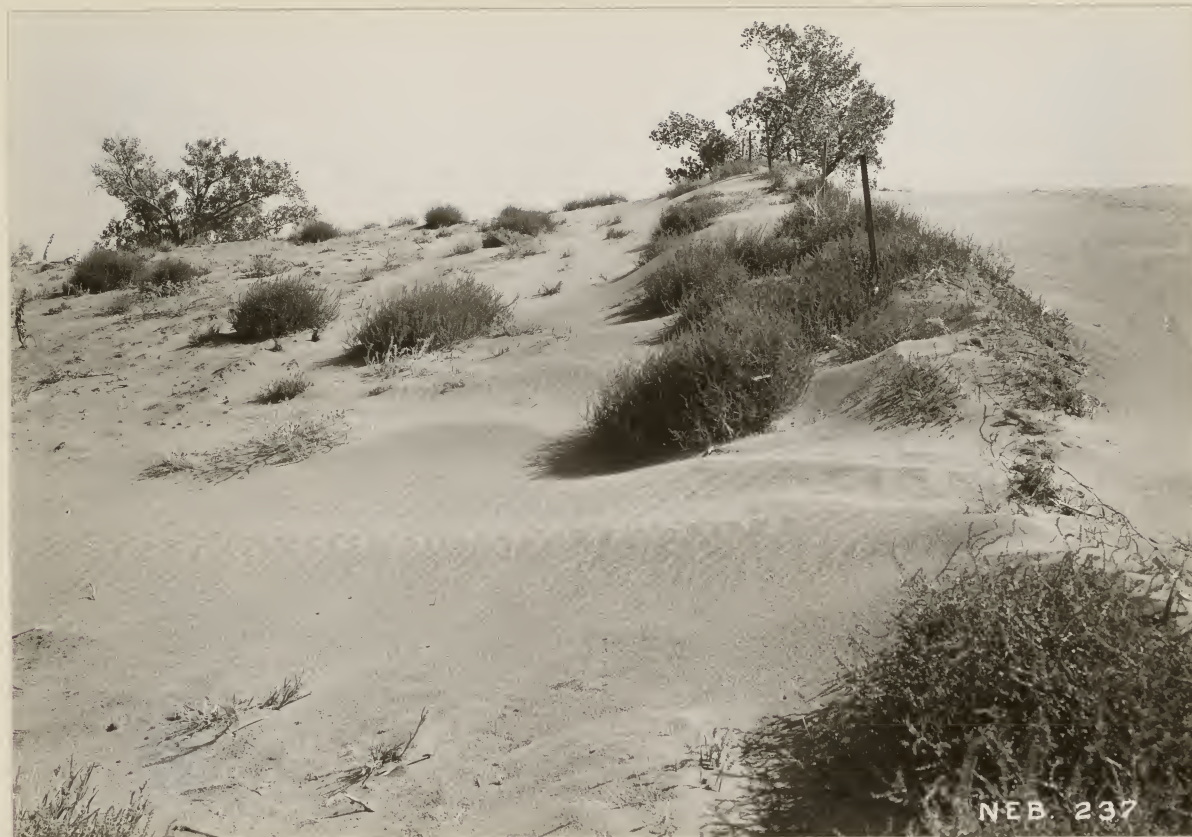
Neb-237. Nebraska.  
EROSION - Silt.

Wind blown silt ruining a formerly cultivated field.

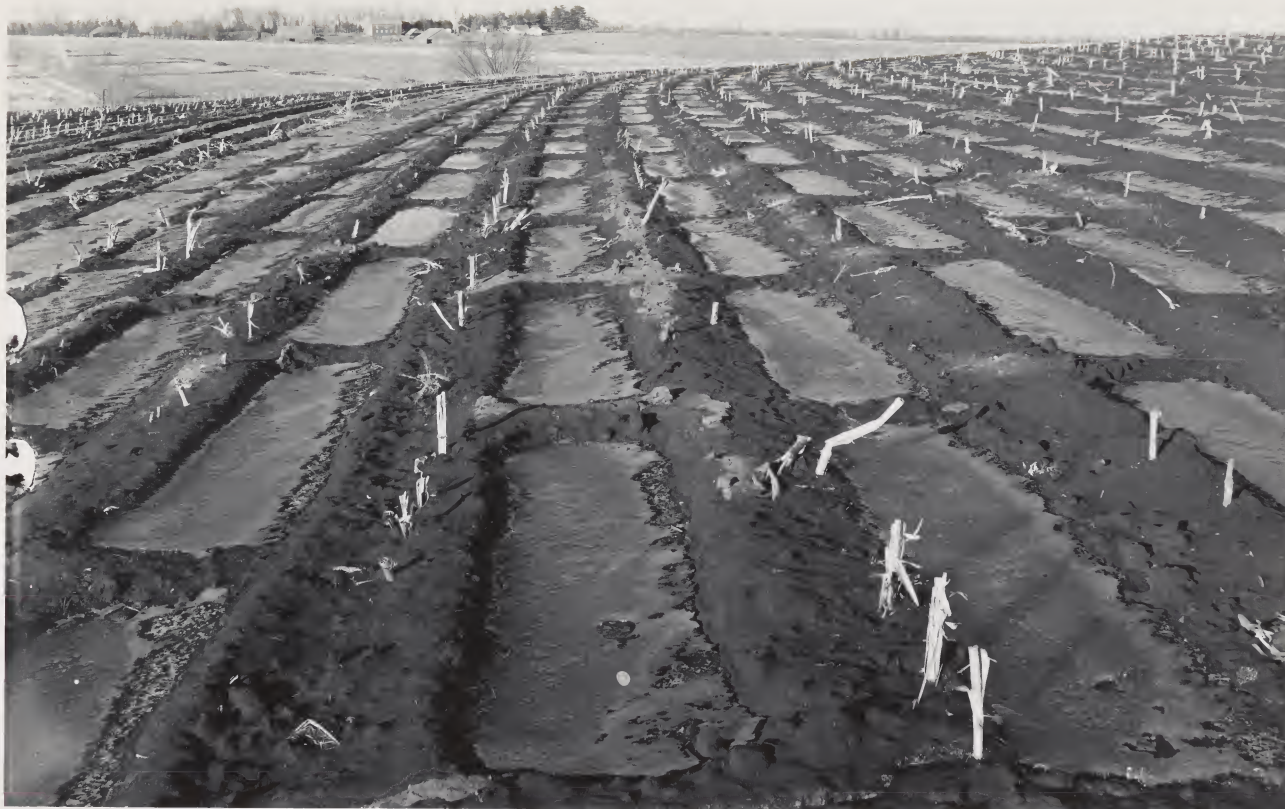
Neb-270

Field, basin listed on contour. Originally there was snow on the field, but it thawed, leaving water in the 8-foot-long basins. During the night, it would freeze, and the next day, the thawing of ice and absorption of the water would continue. Although no exact figures are available, it is safe to say that there was almost no run-off on this field during the winter months. H. M. Fishwood, tenant,  $5\frac{1}{2}$  miles east of Humboldt.

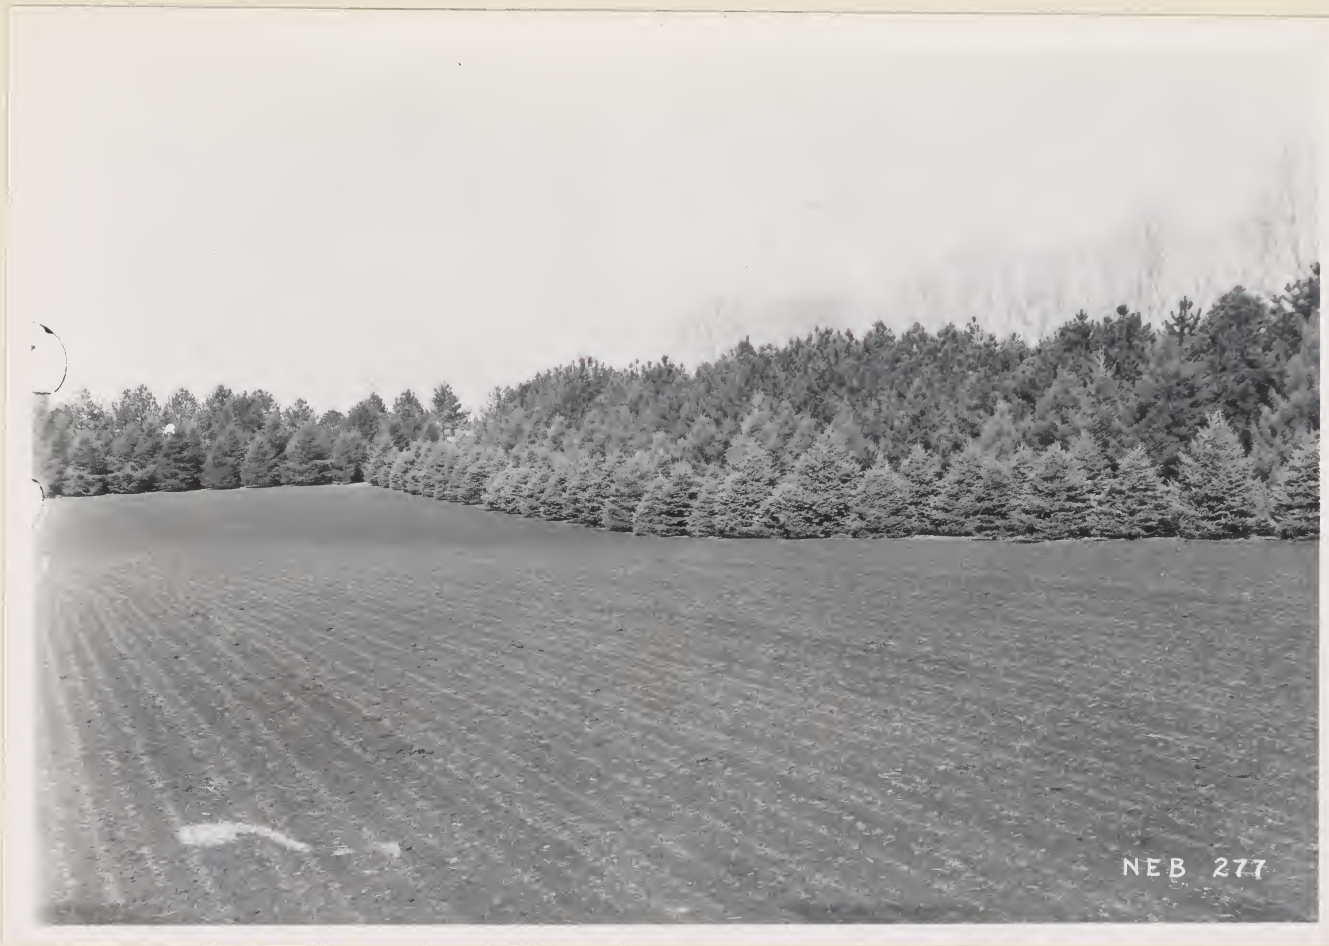
Neb-277

Trees are very effective in causing snows to drift and therefore preserve moisture.

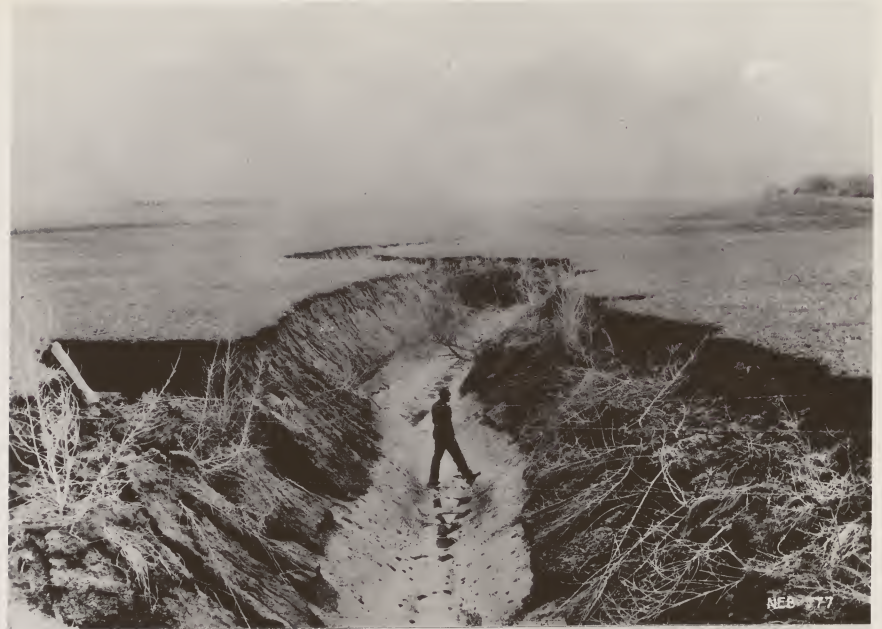
Neb-777      Otoe County      March, 1936  
Weeping Water Camp. Tree planting for gully control. Picture was made in March, 1936. Trees were planted shortly after. Progress picture to follow.

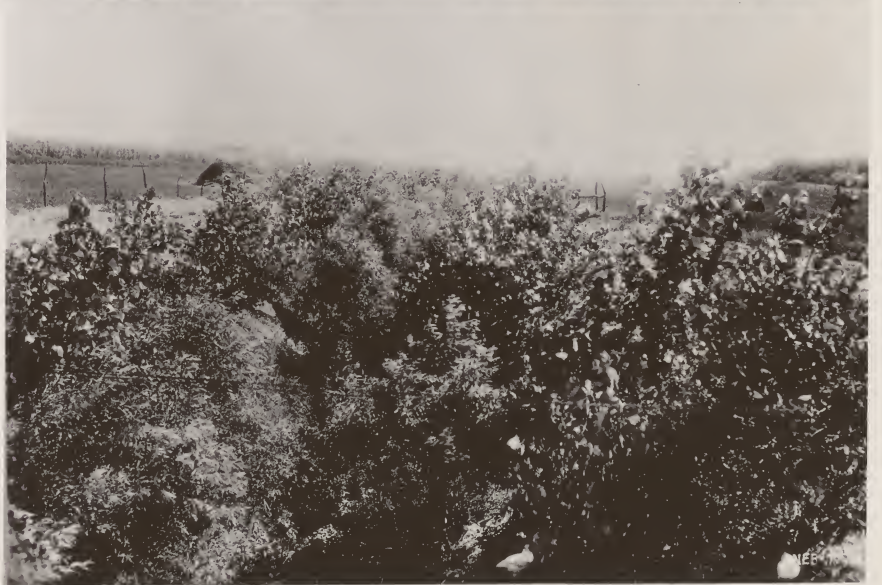
Neb-777-A      Otoe County      August, 1938  
Weeping Water Camp. Tree planting for gully control. "Before" picture was made in March, 1936. Trees were planted shortly after. The gully is now completely stabilized.

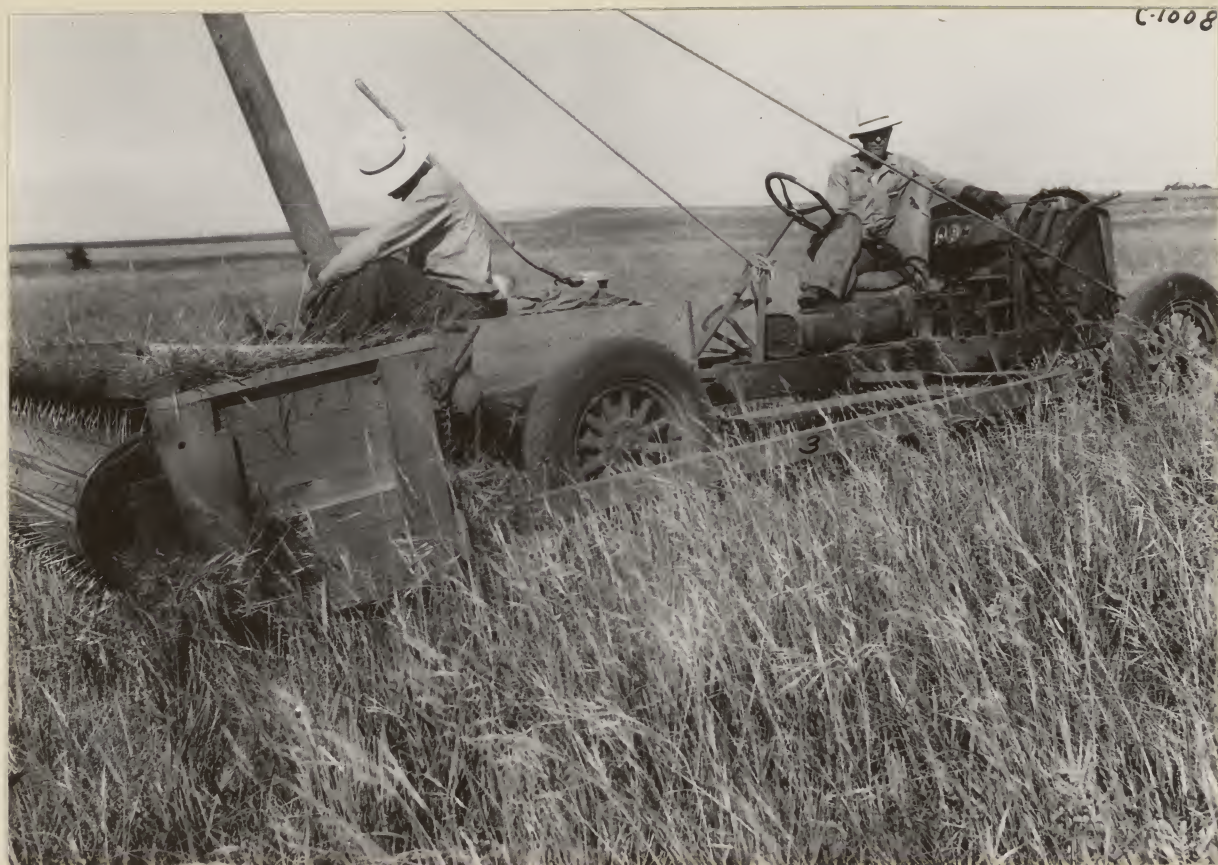
C-1008 - Nebraska.  
Grasses - Harvesting

Side view of new type power stripper.

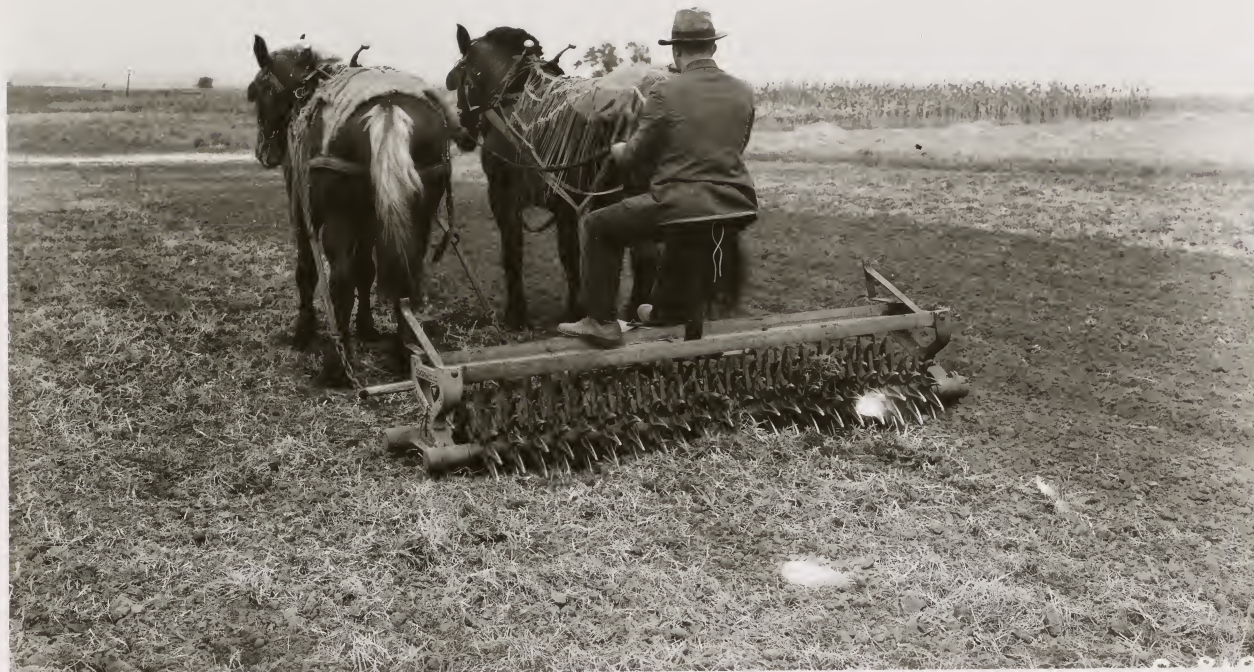
C-8195

Packer at work on land covered with wheat  
residues.

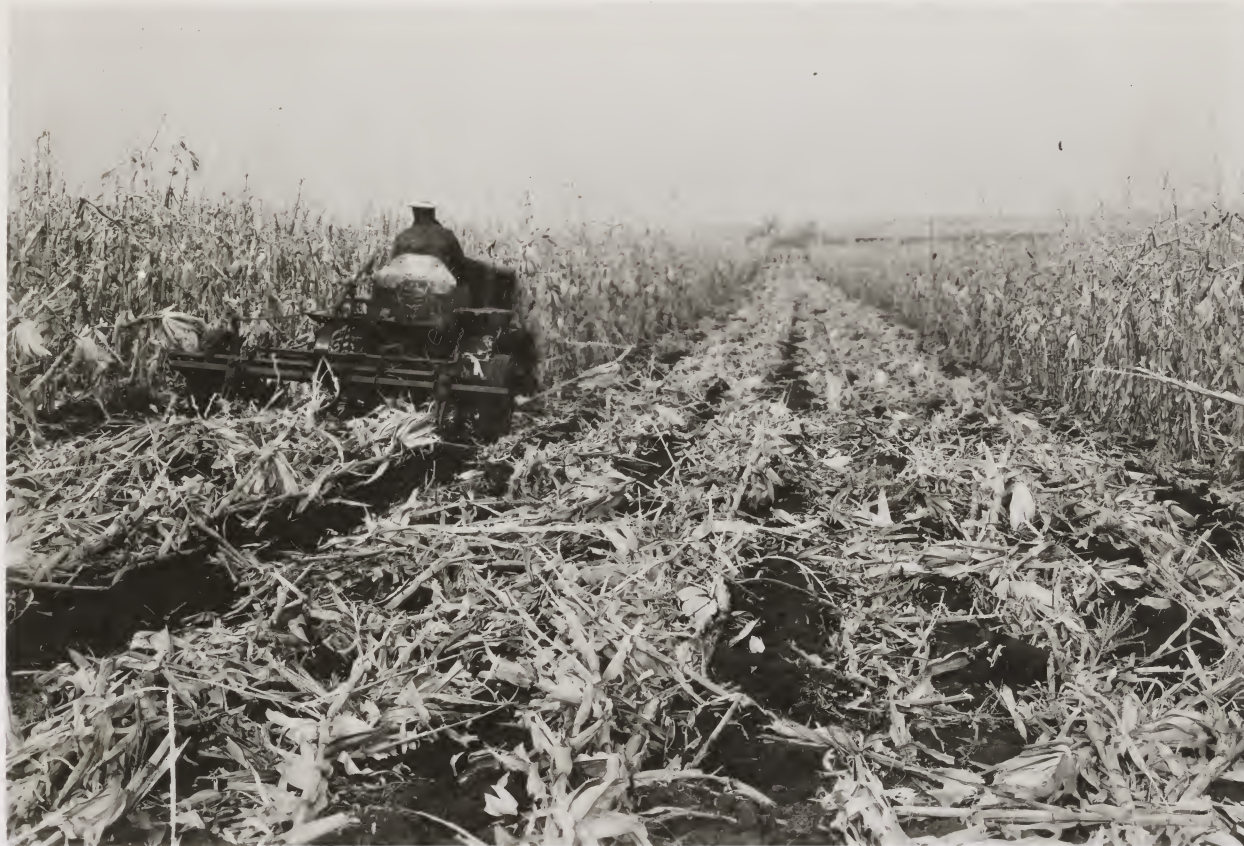
C-8663

Fall sub tillage of corn land where corn made 104.4 bushels per acre. This is being done to increase absorption and prevent erosion from melting snow and early spring rains. This amount of residue should give perfect erosion control even on this 15% slope. Note that tiller works through this heavy residue without clogging.

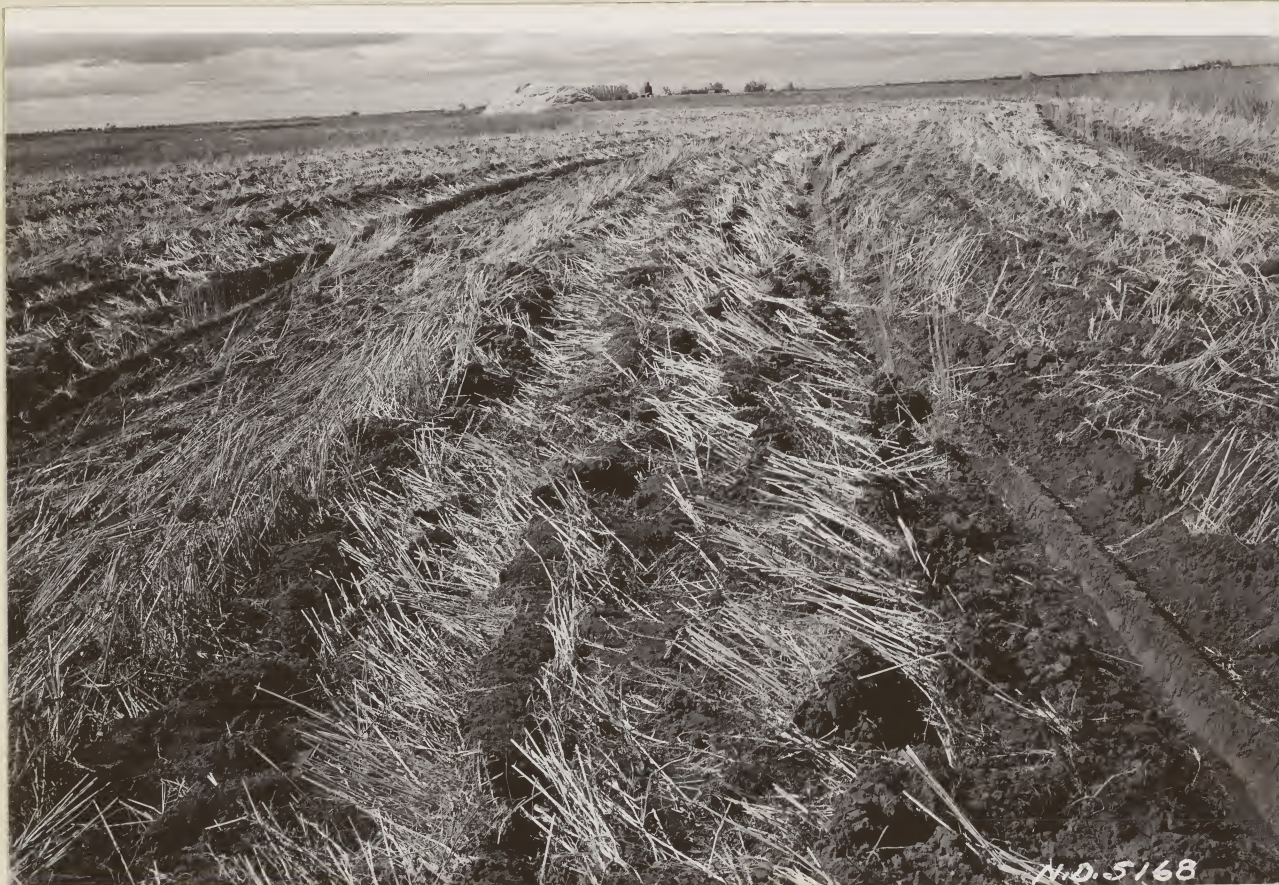
ND-5168

This is how one of Art Vollmer's grain fields looked in September, 1938 after it was tilled with a disk harrow with 20-inch disks instead of the 16-inch disks. The stubble anchored in the loosened soil was designed to give protection against wind erosion and to hold snow on the field.

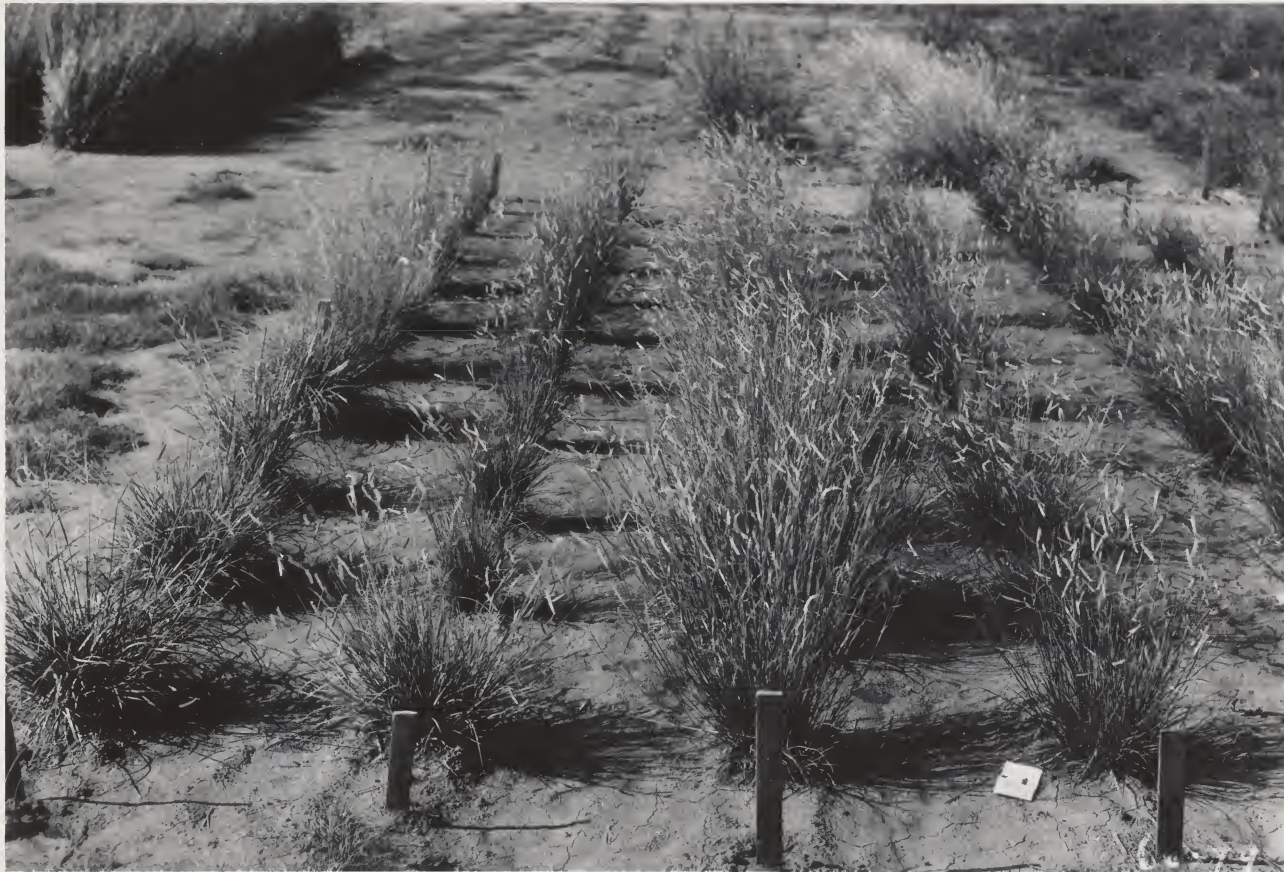
60079

Seed source studies at Lincoln, Nebraska. The blue grama rows shown were grown from seed obtained from: left to right, Okla., Colo., N. M., and Neb.
